**A Compendium of Bonded Repairs  
Applied to the PC9/A Full Scale  
Fatigue Test Article During Testing**

DSTO-TN-0324

**Airframes and Engines Division  
Aeronautical and Maritime Research Laboratory**

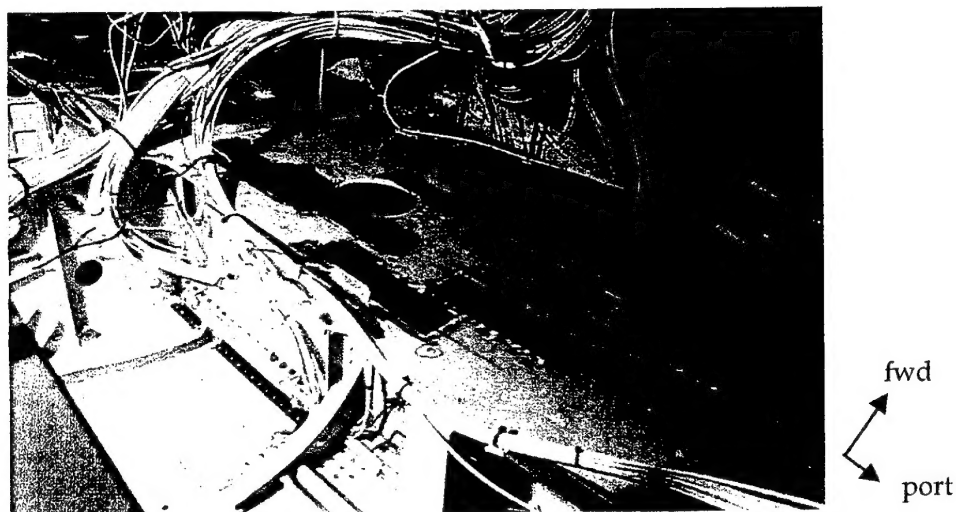
Cracking during testing occurred in the wing centre-section on the lower wing-skin and in the fuselage skin near the tail fin. Figure 2 shows a photograph of the lower wing-skin with all the repairs applied.

Figure 2. *Photograph of the centre section of the lower wing-skin showing repairs.*

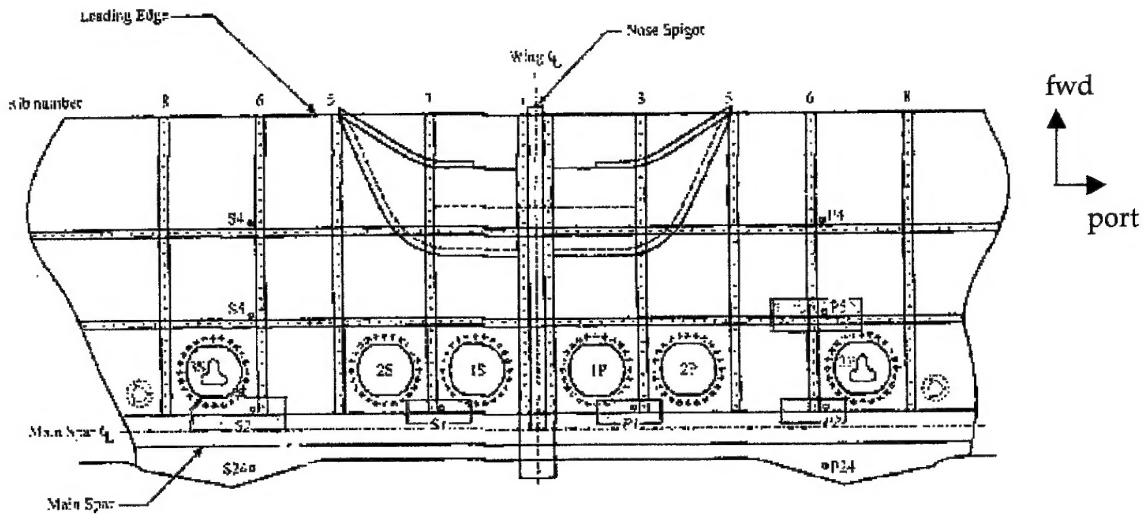
A schematic of the region (from reference 2) is shown in Figure 3. The nomenclature for access holes is 1S, 2S etc for the starboard holes and 1P, 2P etc for the port access holes. For the drain holes, the nomenclature is S1, S2 etc for the starboard side and P1, P2 etc for the port side. The repairs shown over the drain holes were those present at 50,000 SFH.

Figure 3. Schematic of the centre section of the lower wing-skin showing repairs coloured in yellow.

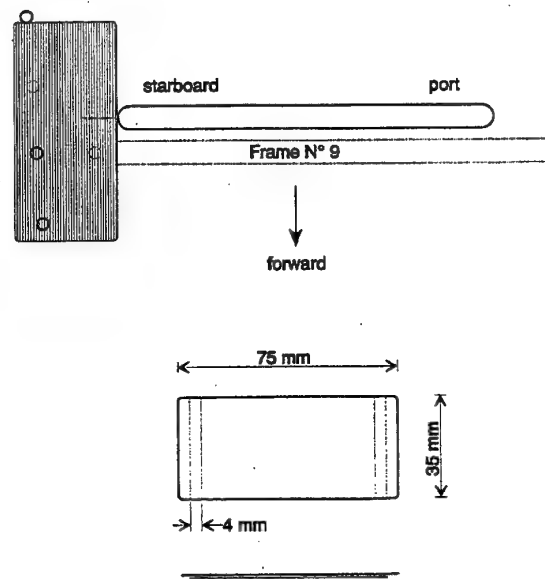
An adhesively bonded boron/epoxy patch was applied to a crack in the top skin emanating from a slotted hole at the forward fin attachment at 6,000 SFH.

Figure 4. Repair to the slotted hole in the top skin at the forward fin attachment

The patch was designed simply on the basis of stiffness matching with the aluminium skin. A three-ply unidirectional boron/epoxy layup was chosen. The thickness of the patch was approximately one third that of the skin as unidirectional boron/epoxy has a modulus approximately three times that of aluminium. The ends of the patches were stepped, at 4 mm per step, to reduce stresses at the patch ends. The patch configuration is shown in Figure 4.

The boron/epoxy patch was bonded to the aluminium skin using the two-part structural acrylic – Click Bond 200-40. This adhesive cures at room temperature and attains 90% of full strength within one hour. No details of the pressurisation method were recorded.

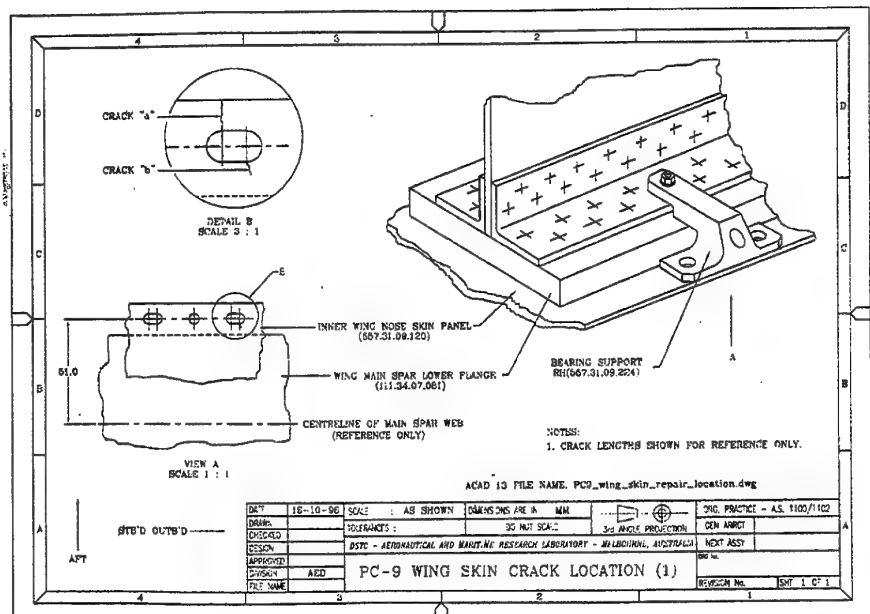
Figure 5 shows the crack location on the starboard wing as at approx. 10,000 SFH.

Figure 5. Starboard Wing Uplock Mechanism- Crack Location.

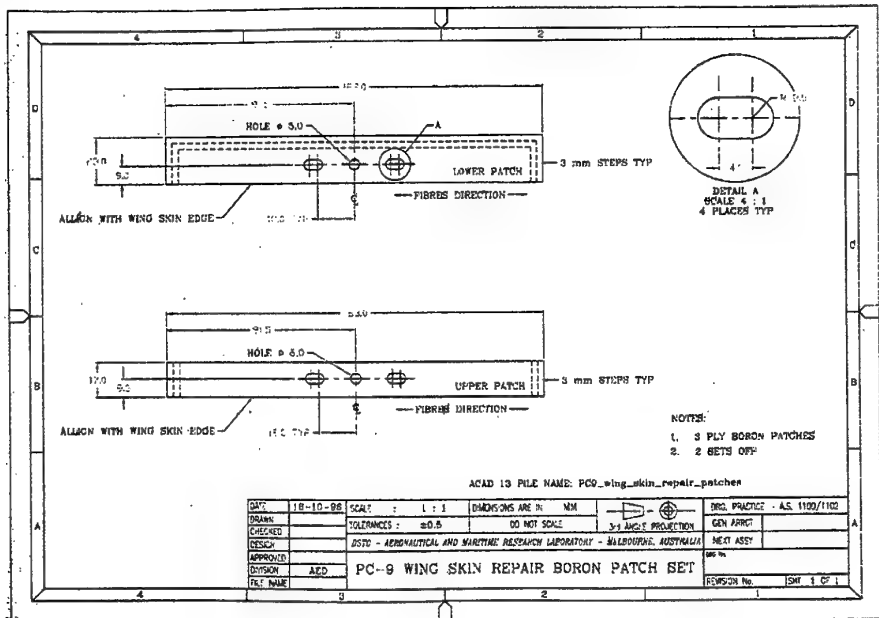
Figure 6. Starboard Wing Uplock Mechanism- Patches.

No crack growth occurred in the starboard lower skin after repair. The patches, which were applied at 10,000 SFH, were removed at 34,000 SFH to allow a re-profiling modification to the region. The port side patches were fitted at about 15,500 SFH. By 17,000 SFH the crack had grown beyond one edge of the external patch. It is thought that the use of the structural acrylic paste resulted in a very thick adhesive bondline which meant that the effectiveness of the patches in reducing crack opening would have been reduced. The patch applied subsequently to the port side used the structural epoxy adhesive FM73. A thicker patch was also employed (a single ten ply patch rather than two three ply patches).

The design and application of these repairs was carried out in accordance with the RAAF Engineering Standard on Composite Materials and Adhesively Bonded Repairs [3]. The structural acrylic adhesive Click Bond 200 was used because it cures at room temperature and it was a requirement of the fatigue test that nearby strain gauges not be damaged by heat. The patch thickness was restricted as the load in the spar could not be affected by the presence of the repairs because this would invalidate the spar lifing calculations. Should such a repair be implemented for the fleet it is recommended that the structural epoxy adhesive FM73 be used. Full design details of the repair are given in Reference 4.

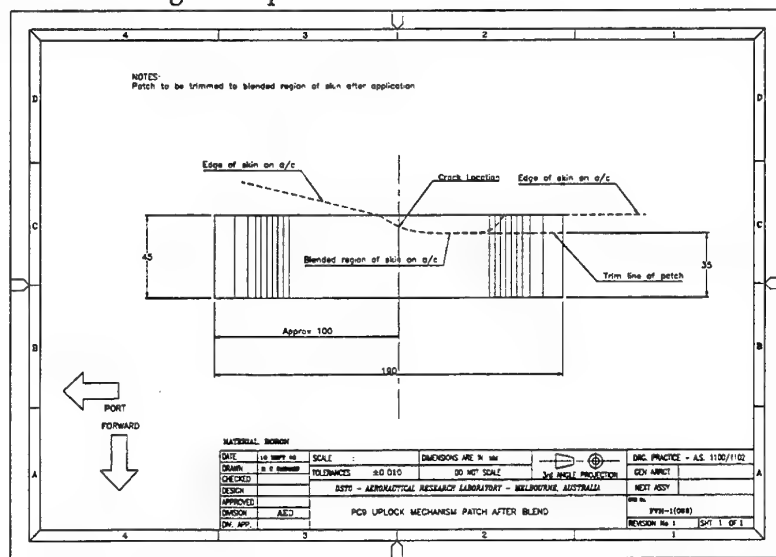
A thicker ten-ply patch was bonded using FM73 to the blended-skin of the port uplock mechanism at 38,000 SFH following re-cracking of this part. At 38,000 SFH the underlying spar had satisfied the requirement of undergoing three lifetimes of loading and so the restriction on patch thickness due to lifing considerations was removed. Eddy-current inspection of the crack showed that this patch stopped crack growth. Figure 7 shows a drawing of the patch.

Figure 7. Drawing of the port uplock mechanism patch applied at 38,000 SFH.

The design and application of these repairs was carried out in accordance with the RAAF Engineering Standard on Composite Materials and Adhesively Bonded Repairs [3]. The design of this patch is as described in Reference 5.

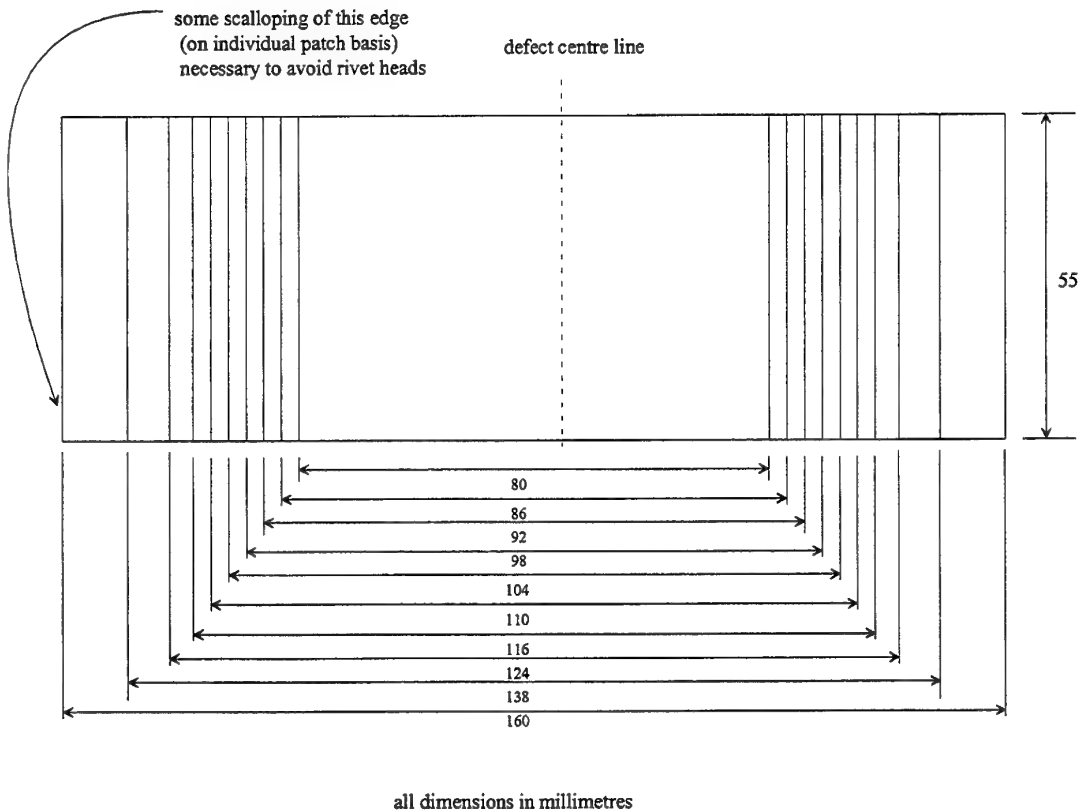
Five cracked lower wing-skin drain holes (P1,P2, S1, P5 and S2) were patched as shown in Figure 3. The drain holes were progressively patched between 23,875 SFH and 44,000 SFH (see Table 1) at scheduled downtimes for the test rig so as to minimise disruptions to the test. The locations of the drain hole patches were shown in Figure 3. The boron/epoxy patches stopped crack growth. A drawing of the generic patch applied to the drain holes is shown in Figure 8.

Figure 8. Drawing of the generic patch applied to the drain holes.

Details on the design and application of the drain hole patches are given in Reference 6.

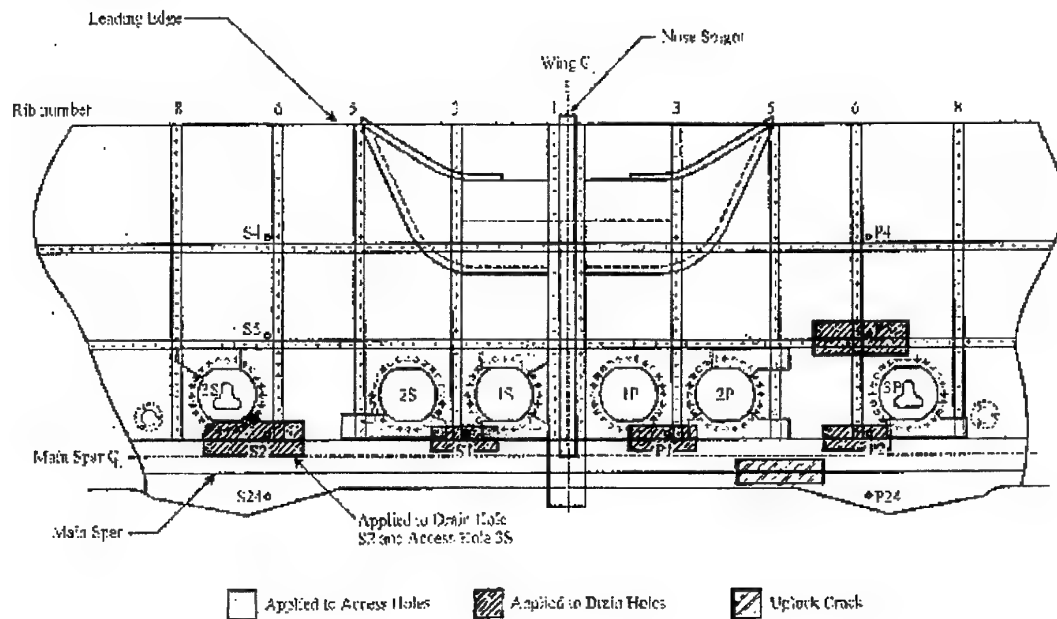
Seven patches to six cracked lower wing-skin access holes were applied progressively from about 37,000 SFH. The locations of the drain hole patches are shown in Figure 9. Inspection by eddy currents showed that the boron/epoxy patches were very successful in stopping crack growth.

Figure 9. Drawing showing the locations and the nomenclature for the access hole repairs [2].

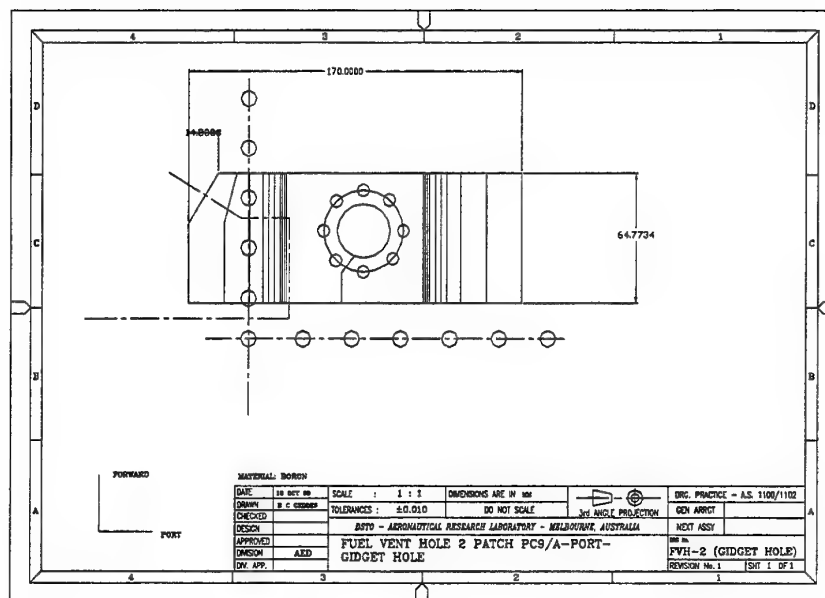
A patch was applied to the port fuel vent hole located just outboard of access hole P3 (see Figure 9) at 52,000 SFH. Figure 17 shows a drawing of the patch. The patch was ten plies thick and design was as for that given in Reference 5.

Figure 17. Drawing of patch applied to the port fuel vent hole.
